## 1967-1969 Cougar Turn Signal Switch Failure Diagnosis

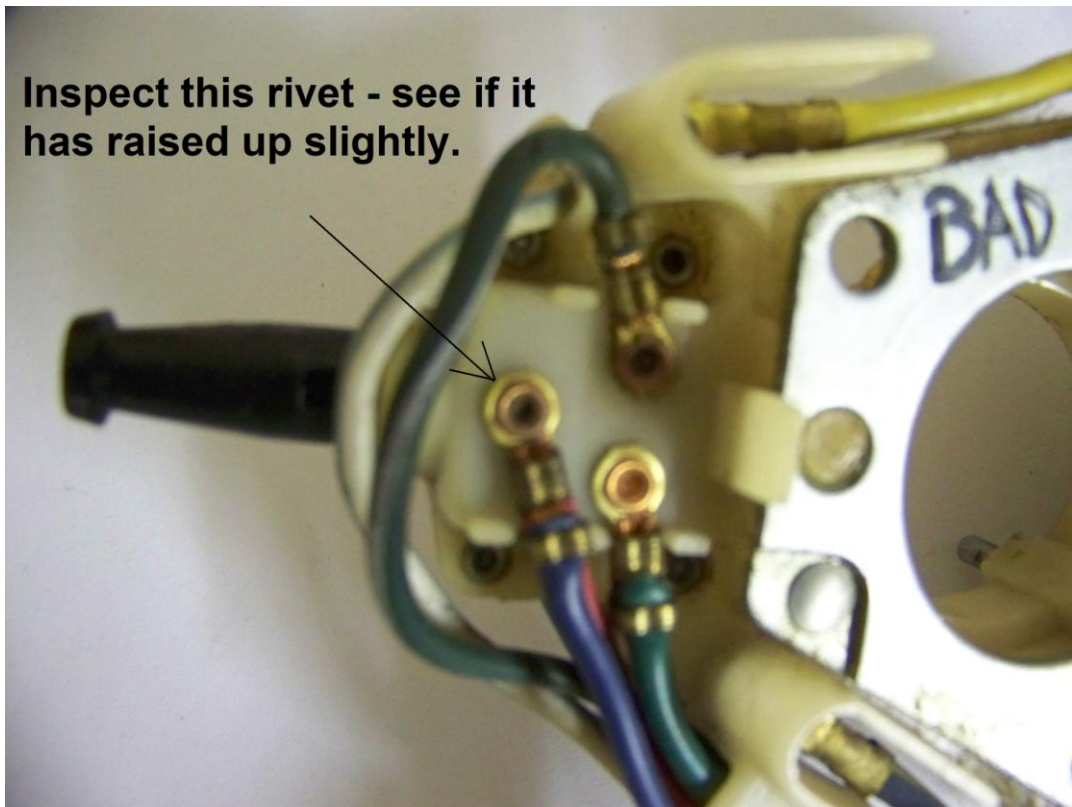
**Figure 1. Turn Signal Switch Bottom View**

*All* the turn signal light power passes through the emergency switch portion of the switch first. On Cougars, Thunderbirds, and Shelby Mustangs, the current from the extra tail lights can heat up the riveted connections, soften the plastic housing, and allow the rivet to move out of position. This will cause the turn and/or emergency signals to fail.

Inspect the rivet location carefully to see if the rivet has raised up slightly as shown in Figure 1. The rivets on both the top and bottom of the switch should be flush with the plastic housing.

When the rivet moves up, it disconnects the top wire from the bottom, interrupting power feeding from the emergency switch section to the turn signal side of the switch.

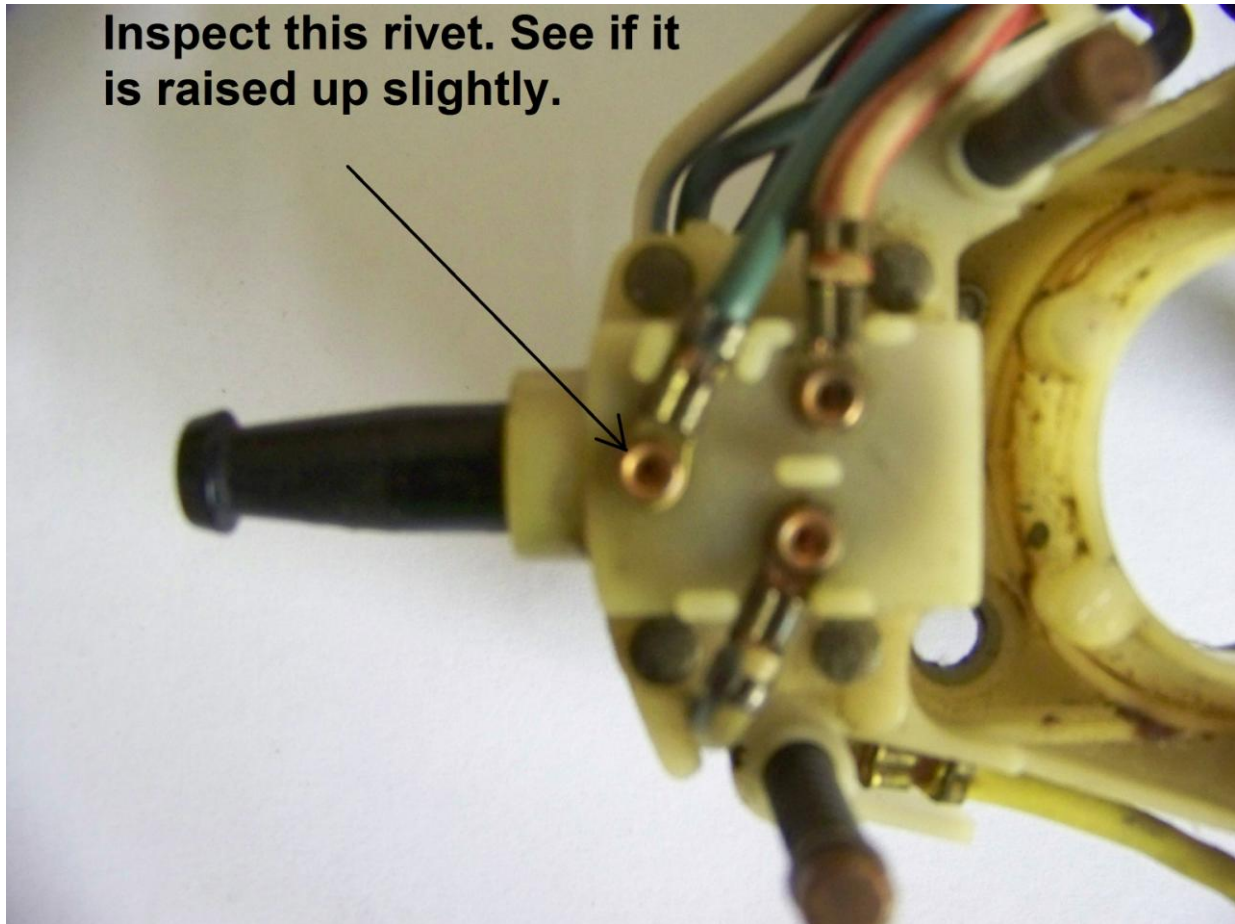
### **Turn Signal Switch Top View**

Inspect the rivet location carefully to see if the rivet has raised up slightly. It should be flush with the plastic housing.

Measure the resistance between the points shown below. It should be zero. If there is a high resistance open between these two points, the switch has failed.

Another common failure is oxidation between the rivets and the terminal with the wire. Measure the resistance between the center of the rivet and the terminal for each wire. A high resistance indicates an open. This may be repaired by soldering between the rivet and the terminal end using low-temperature solder. Warning: too much heat will melt the switch housing and move the rivet, ruining the switch.

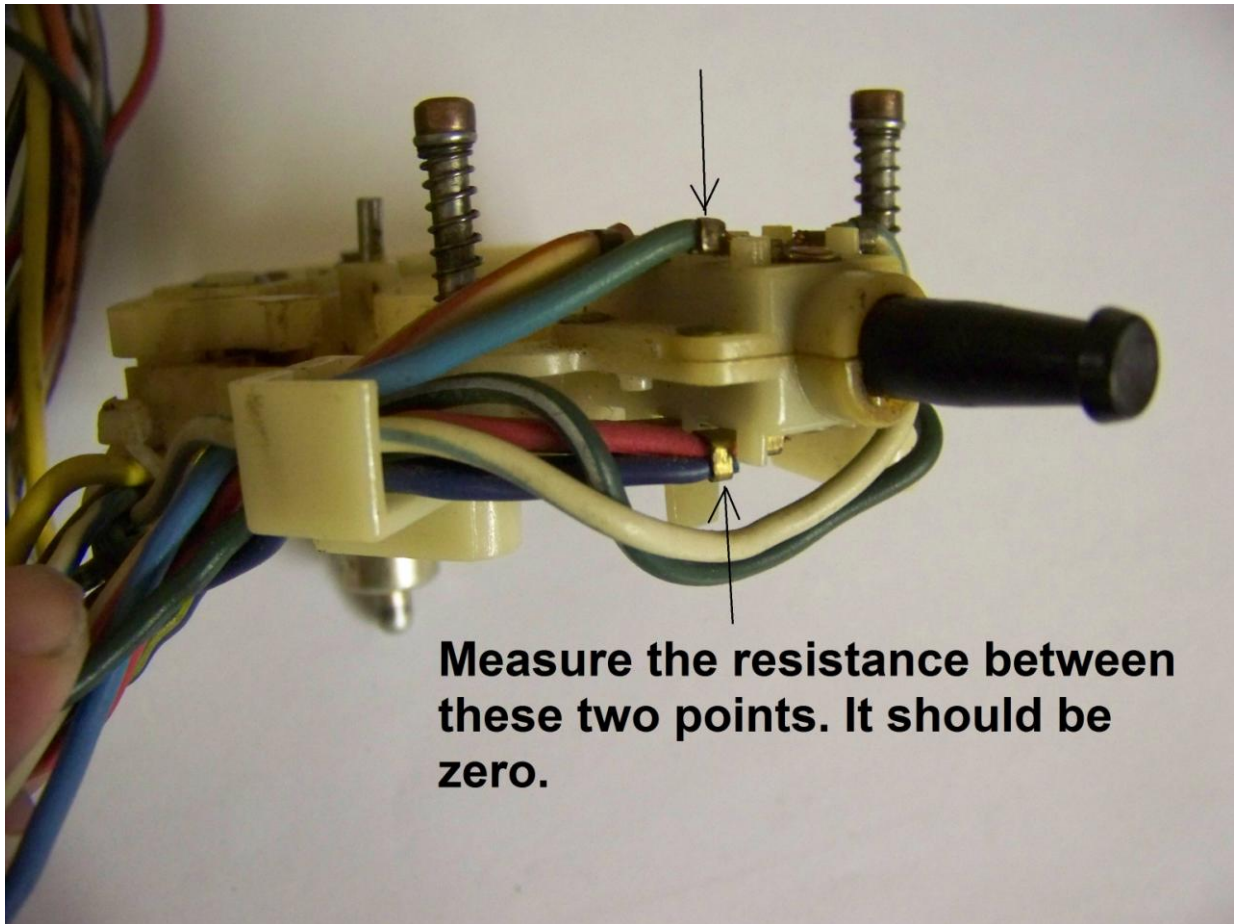
**Figure 3. Turn Signal Switch Side View**

Measure the resistance between the points shown in Figure 3. It should be zero. If there is a high resistance open between these two points, the switch has failed.

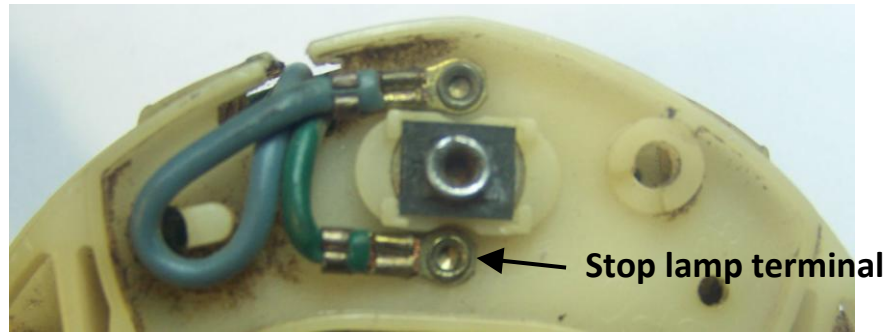
**Figure 4. Stop Lamp connection – switch top view**

Stop lamps can fail at:

1. terminal on the switch plate – oxidized rivet or crimp connection. See previous section on repairing this problem. Replace the switch if unrepairable.
2. turn signal switch connector pin (green wire from the stop lamp switch, see below).

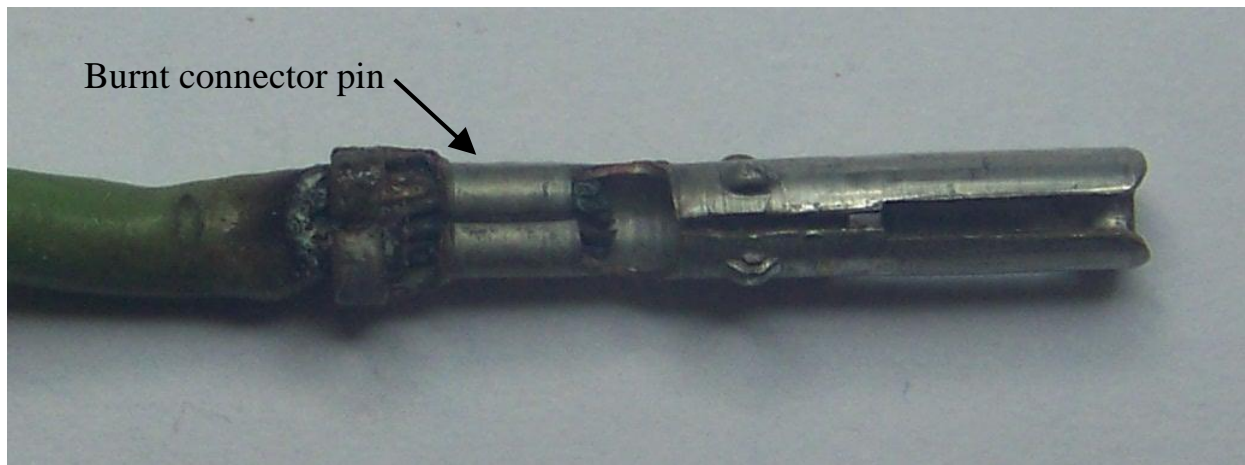
**Figure 5. Turn Signal Switch Connector Pin Failure**

Figure 4 shows a common turn signal switch connector pin failure. The crimp connection between the wire and the pin is burnt and oxidized due to the high stop lamp current. A high resistance open between the green wire and connector pin will cause stop lamp failure or intermittent operation. This problem can occur on either the male or female side of the turn signal switch connector.

To inspect the pin, remove the pin using a pin removal tool (see the factory shop manual for a picture of the tool). To repair, replace the socket or pin, or the switch. Make sure the switch comes with *new* pins – do not use crimp on connectors.
