1971 Cougar Sequential System Grey Connector Conversion

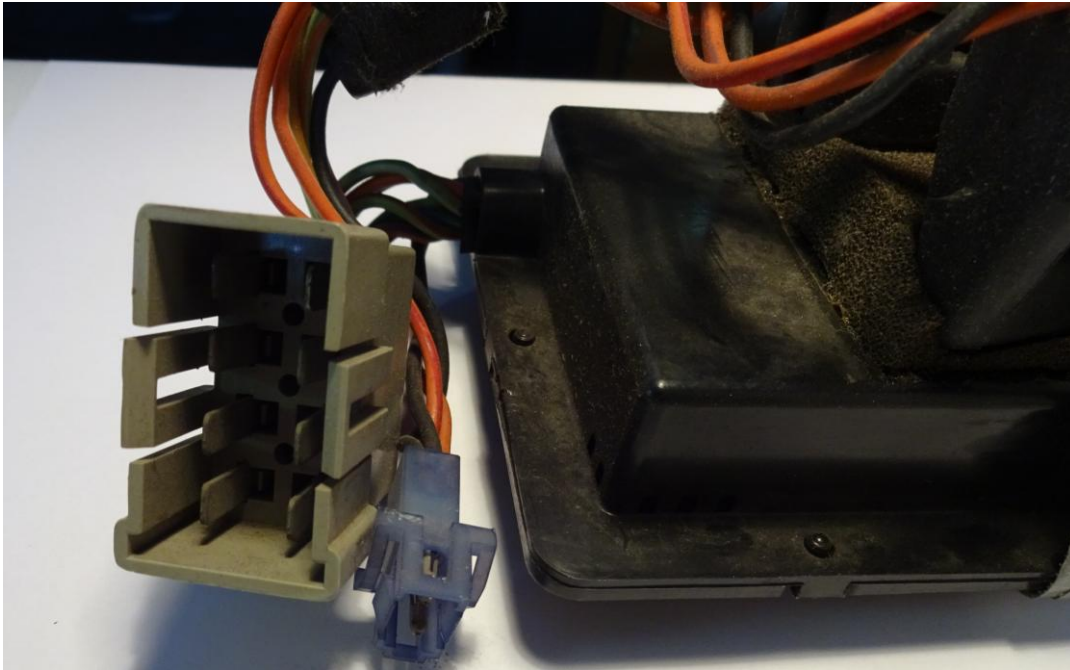
D1WY-13A366-C sequential system used on 1971 Cougars built from 2/1/71 to 5/15/71

1971 Cougars built from 2/1/71 to 5/15/71 used a unique sequential system in the trunk, D1WY-13A366-C. It uses two connectors, grey and light blue, that are no longer serviced. When the sequential system must be serviced, it can be replaced by an NOS unit, or a replacement unit, such as the C9WY-13A366-AL sequencer shown below.

Since these unique connectors are no longer available, the connector plugs on the tail light harness must be replaced with the more typical red and black plugs. The C9WY-13H366-AR harness connector repair kit provides these plugs along with about 12" of wire for splicing.

Installation requires cutting off the old grey connectors and splicing on the new red/black connectors while matching up the wire color codes. Slide heat shrink tubing over each wire and solder (no butt splices) each connection. Wrap the bundle with electrical tape to protect the connections. Remove the old sequential system board from the black case, install a new C9WY-13A366-AL sequential system board and plug into the harness. Replace the turn signal flasher can with a D0WY-13A366-AR when using 1157 bulbs or a D0WY-13A366-L flasher when using LED bulbs. Remember to test both the turn signals and brake lights prior to driving the car.
